Asbestos Pipework Insulation Removal

Site: London

PROJECT

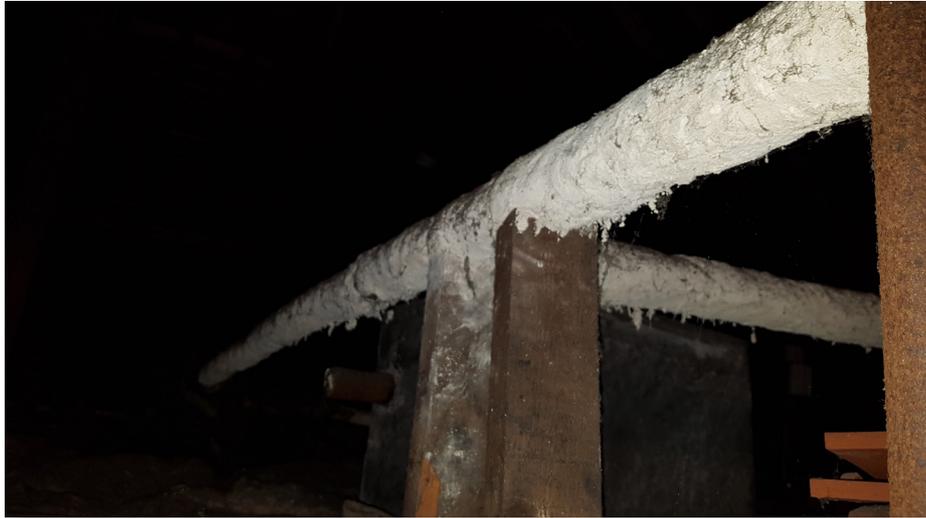
Amiante STR Ltd were instructed by a domestic client to remove badly damaged insulated, pipework from a loft space from her property in London. The insulation to the pipework was in very poor condition, and could pose a health risk if disturbed. With this being said strict safety precautions are paramount for all jobs involving more friable or fibrous forms of asbestos such as asbestos insulation board, pipe lagging and sprayed coatings.
